BEFORE THE
PIPELINE AND HAZARDOUS MATERIALS SAFETY ADMINISTRATION
U.S. DEPARTMENT OF TRANSPORTATION

Advance Notice of Proposed Rulemaking

Hazardous Materials:
Rail Petitions and Recommendations To Improve the
Safety of Railroad Tank Car Transportation

PHMSA-2012-0082 (HM-251)
Published: 78 Fed. Reg. 54,849 (Sept. 6, 2013)

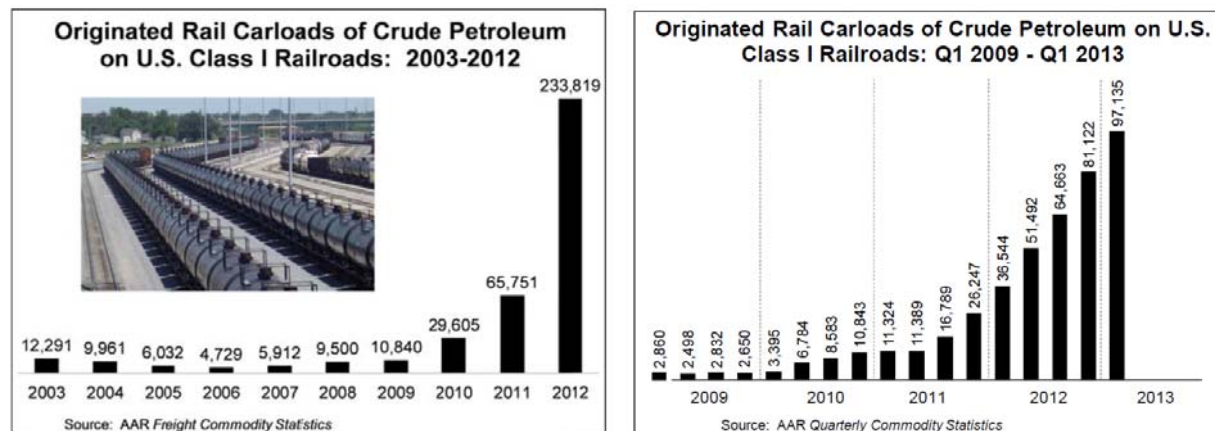
Figure 1: The growth of rail as a means of crude transport

¹³ Fielden, Sandy, RBN Energy, "On the Rails Again? – Bakken Crude Rail Shipments Return to April Highs." <http://www.rbnenergy.com/on-the-rails-again-bakken-crude-rail-shipments-return-to-april-highs> October 30, 2013. See also Figure 1

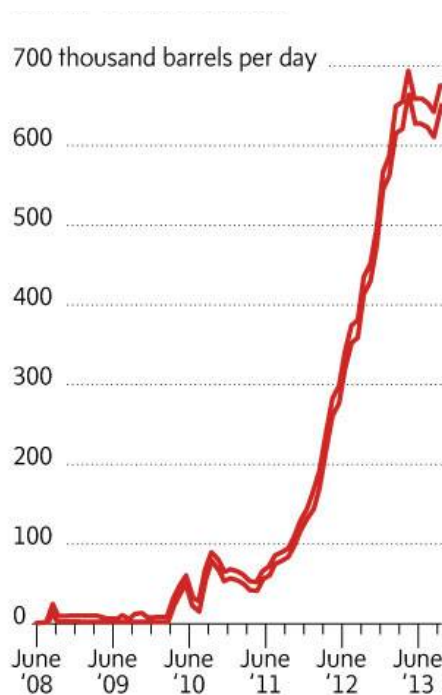
**ND Oil Export Volumes by Rail
(June 2008-September 2013)
High-Low Estimates¹⁰**

¹⁰ Rail volumes are estimated as a range based on estimates of total crude production, less volumes to pipeline, truck, and local refining. <http://northdakotapipelines.com/rail-transportation>

As shown in the data from North Dakota¹¹ and AAR,¹² crude-by-rail volumes increased rapidly from 2009 into the second quarter of 2013, then dipped for several months as a result of crude pricing that encouraged a shift to pipeline transport.¹³ Later in 2013, pricing was again

¹¹ See Figure 2 and North Dakota Pipeline Authority. Ibid.

¹⁴ Ibid. See also Figure 2.

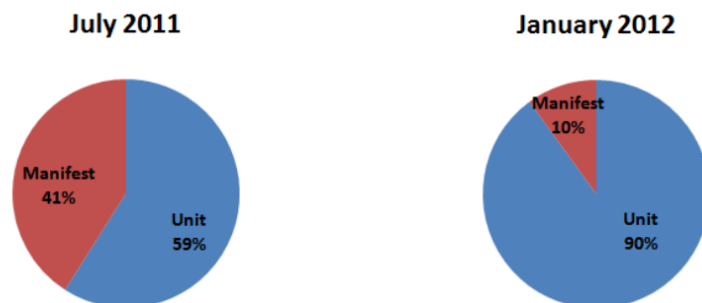
Figure 3: Slide from a presentation by Craig Johnson, Gen. Director – CTS, Union Pacific Railway at the Crude-in-Motion Conference 2013

Crude Oil Manifest vs. Unit Trains

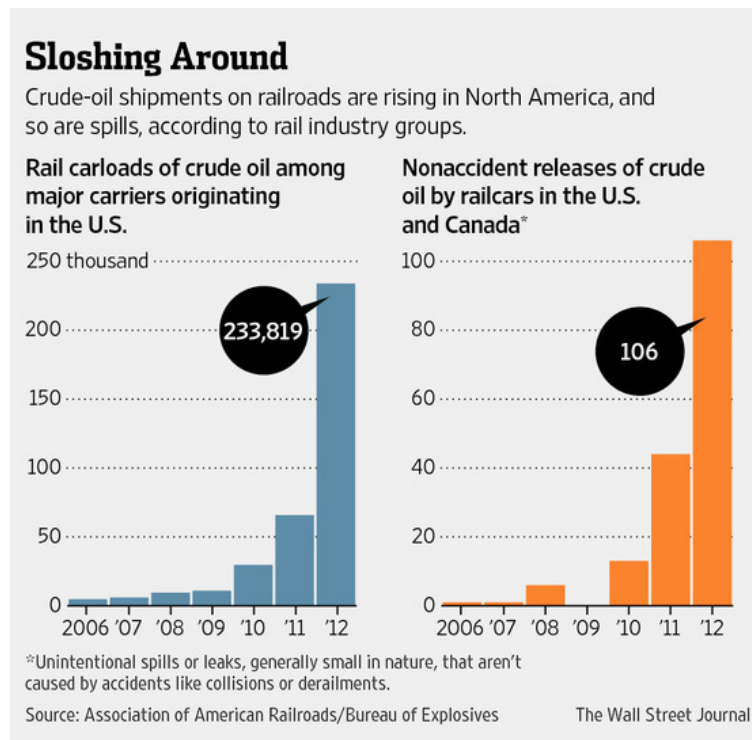
Figure 4: Industry shipment and incident reports

Similar statistics were published by the Wall Street Journal, based on data generated by the Association of American Railroads (“AAR”):²¹

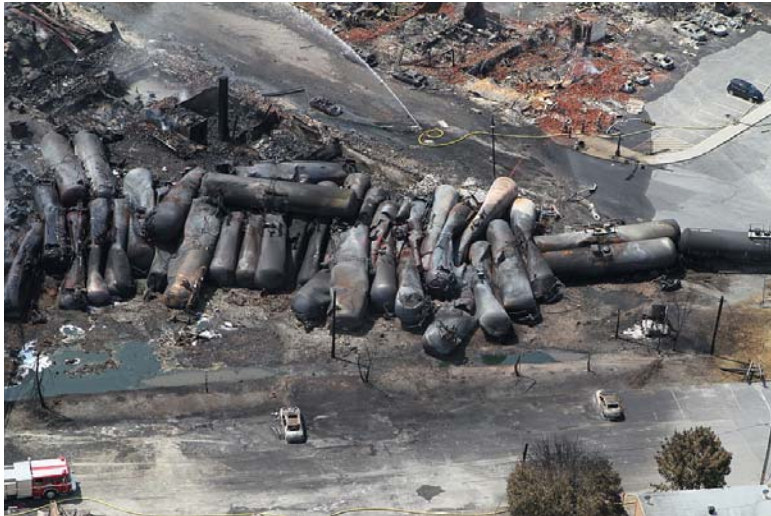
Figure 5: Post-accident aerial photo of Lac- Mégantic (Reuters)

located in Quebec. Owned by an American company – Montreal, Maine and Atlantic Railway – the train had only a single staffer, who abandoned the train in order to sleep in a motel before a replacement crew arrived to complete the train’s journey to an oil refinery on Canada’s east coast. The brakes on the five-locomotive train malfunctioned, and it began a seven-mile roll toward the small town. Reaching a speed in excess of 60 m.p.h, the train reached a bend in the tracks, derailing and dumping 1.6 million gallons of its contents, which caught fire and incinerated dozens of buildings. Forty-seven people were killed.²³

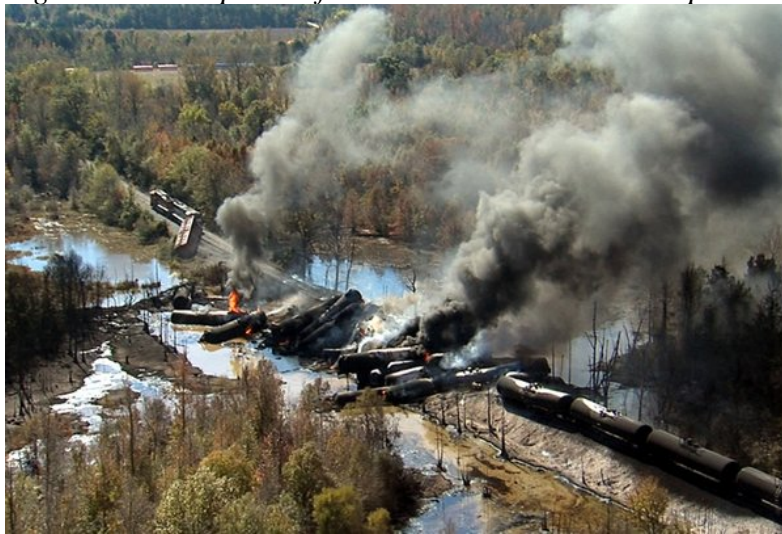
Figure 6: Aerial photo of Alabama derailment and explosion (Reuters)

On November 8, 2013, a 90-car unit train carrying 2.7 million gallons of crude oil derailed and exploded in a rural wetland in western Alabama, spilling crude oil into the surrounding wetlands and igniting a fire that burned for several days.²⁵ No injuries resulted from the accident, but a similar accident in a more populated location would certainly have caused serious risk to public safety.

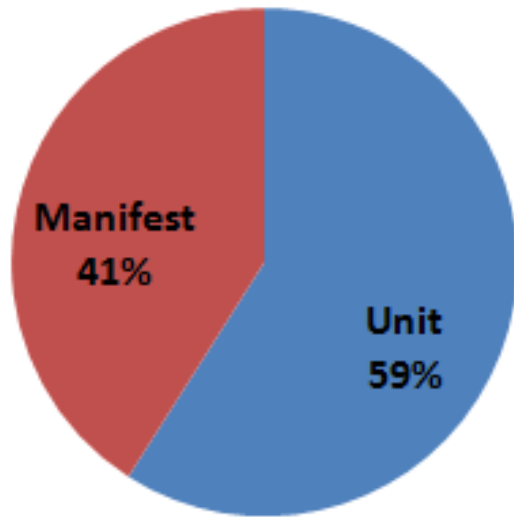
Crude Oil Manifest vs. Unit Trains

July 2011

January 2012
